NASA TM X-935

ULTRASONIC WELDING OF A
BERYLLIUM WINDOW ASSEMBLY

*Goddard Space Flight Center
Greenbelt, Maryland*

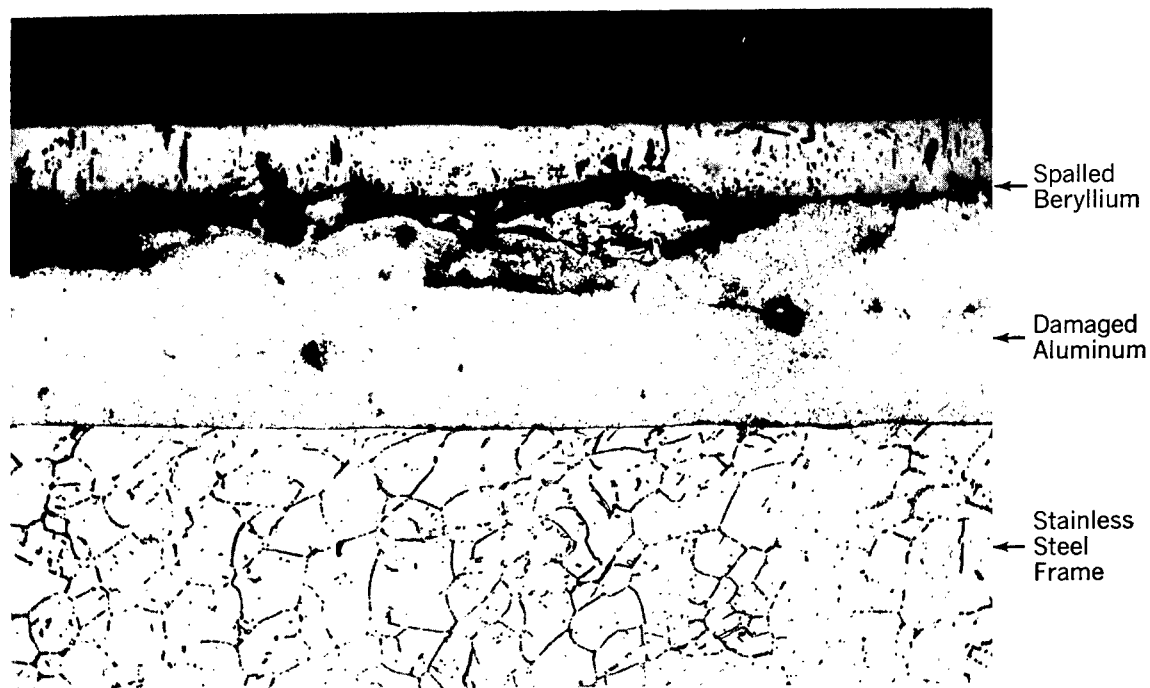
Figure 6—Photomicrograph (500X) beyond ultrasonic weld, showing foil damage. Stainless steel frame etched electrolytically in 10 percent oxalic acid. Beryllium etched in 10 percent HF, 90 percent ethanol.

A portion of the section at the edge of the land area is shown in Figure 5. A sound bond is apparent over the land where pressure was applied. Deformation of both the aluminum and beryllium has occurred beyond the land. The section beyond the land (Figure 6), shows damage to the beryllium; spalling has occurred beyond the contact area of the sonotrode and land.

The spalling noted adjacent to the land is attributed both to deformation of the land itself and to the introduction of ultrasonic energy causing induced vibration in unsupported beryllium of poor quality. The tendency to spall should be lessened in sound beryllium. In addition, it may be reduced by changes in welding practice, such as narrowing the annulus of the sonotrode or providing damping for the unsupported section of the beryllium.
